**COPEDEC IV CONFERENCE ON COASTAL AND PORT ENGINEERING IN DEVELOPING
COUNTRIES**

25-29 September 1995

Rio de Janeiro, RJ, Brasil

THE MIGRATION OF THE MOUTH OF SERGIPE RIVER IN NORTHEASTERN BRAZIL AND ITS CONSEQUENCES FOR THE DEVELOPMENT OF THE REGION - A CASE STUDY

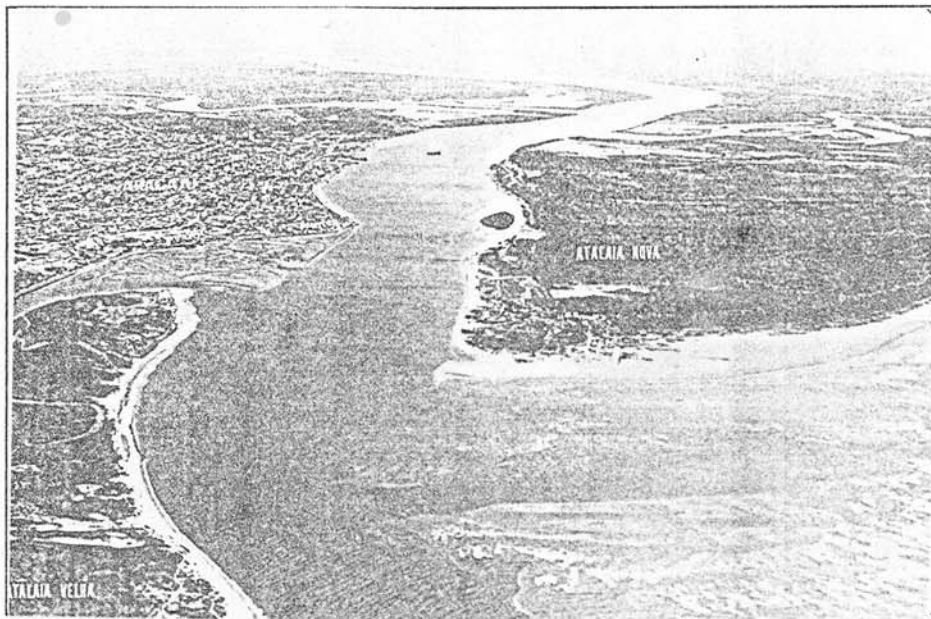
Figure 2: Sergipe River Mouth (October 26,1976 - 12:30 PM - WL = +0.2 m)

For the occupation projects to be implemented, the natural ecosystem was severely impacted with the destruction of an extense mangrove area for land reclamation, initiated in 1977 (Figures 2 and 3).

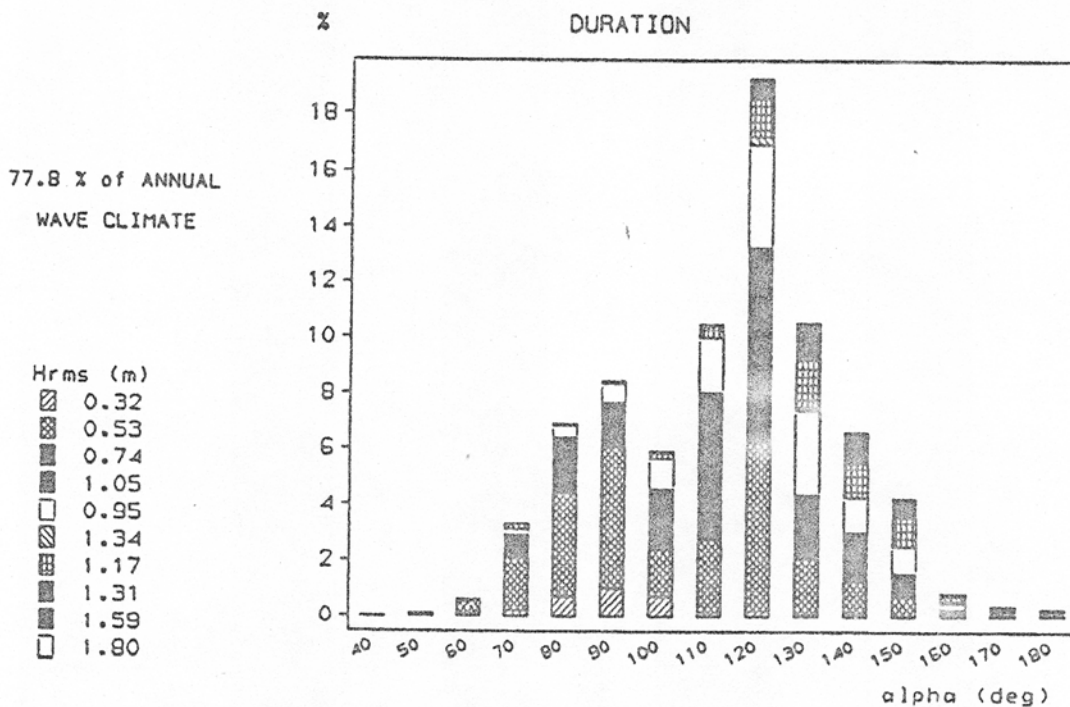
- 1- the waves come predominantly from the northern sector of the beach normal (azimuth of 125°), presenting a wider direction distribution than those propagating from the southern sector (Figure 4);

**Figure 4: Offshore wave climate near Sergipe Marine Terminal
from (PLANAVE & DHI, 1992)**

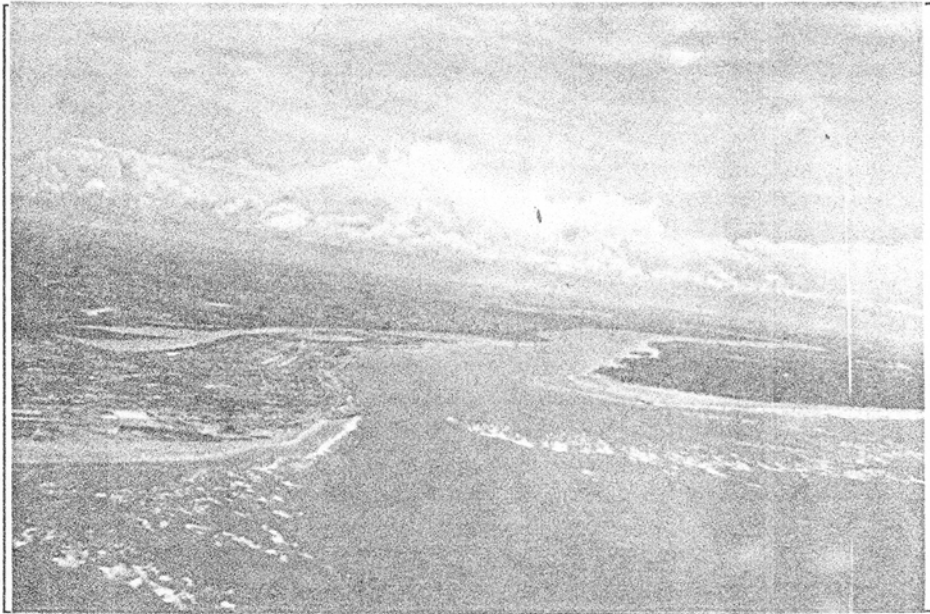
Figure 8: Sergipe River Mouth (April 4,1995 - 11:40 AM - WL = +0.4 m)

A field inspection was carried out by the authors in April 1995. The photo (Figure 8) shows that a great extension of the 850m long jetty is now covered by sand, with its northern side almost filled up. Due to the intense eolian sand transport over the jetty (not considered in the previous studies) and the contour of its extremity by the littoral drift, also the southern side of the structure is already strongly accreted for some 400m to SW. This accelerated growth of Propriá Point has been promoting the talweg migration and forcing the tidal currents more and more against the right margin, worsening the erosive process at Coroa do Meio. It can be seen in Figure 8, by observing the breaking of the waves, that the region of the deeper and narrower portion of the tidal channel through the mouth, is dangerously close to the right margin.
