GENERAL IMPROVEMENTS OF THE IPR-R1 TRIGA MARK I REACTOR IN 37 YEARS OF OPERATIONS

Fausto Maretti Júnior, Márcio Prado Fernandes, Paulo Fernando Oliveira e Valter Alves de Amorim

Centro de Desenvolvimento da Tecnologia Nuclear/ CNEN
Caixa Postal 941
30123-970, Belo Horizonte, Minas Gerais, Brasil

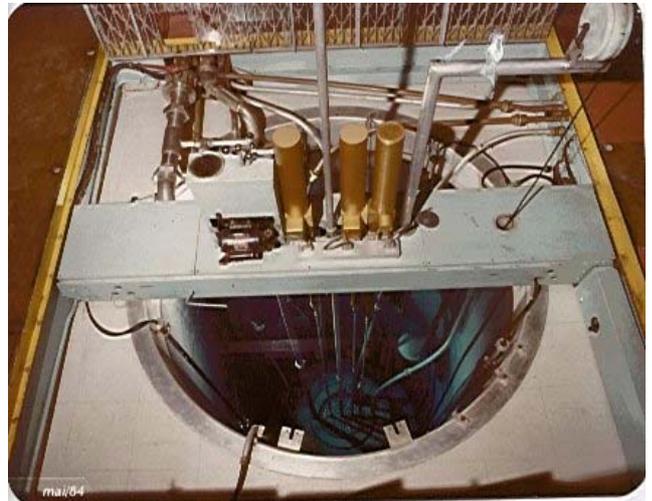
Figure 1. The IPR-R1 TRIGA Mark I Reactor

The reactor core is located at the bottom of a tank under approximately 6.5 meters of shielding water, the open top of the reactor tank being at floor level. The irradiation facilities have physical and visual access to the core and large-volume assemblies can be irradiated through the water column as shown in Fig. 1

The reactor core consists of a lattice of 59 cylindrical fuel-moderator elements and 27 graphite elements, with the water of the tank occupying approximately 35% of the core volume. A radial graphite reflector surrounds the core that is water cooled by natural circulation.

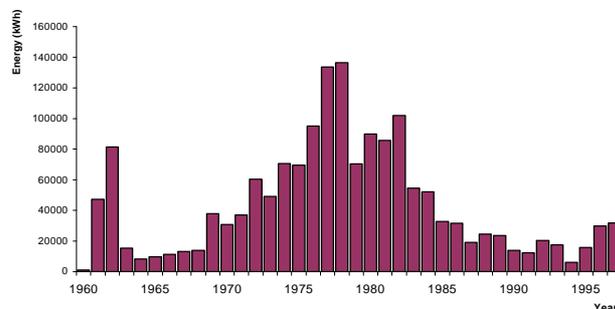
Figure 2. Energy Released in 37 Years

The energy released and the total samples irradiated in 37 years are showed in Figures 2 and 3.

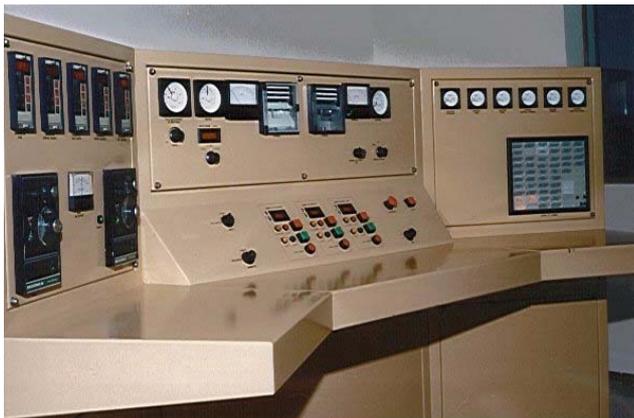
Figure 4. The IPR-R1 Reactor New Control Console

During a two year period, groups of specialists from CDTN and the Nuclear Engineering Institute (IEN), researched and built a new control console, totally manufactured with solid state components which is now in operation. The operation with the new console permitted to operate the reactor with greater safety than the old one because improvements made the safety parameters [Figure 4].

The equipment changed consisted of the strip chart recorders of the power channels and later the conductivity meter, the water and area radiation monitors, and the instruments to the new cooling system. Through the years, it various problems happened with replacement valves, circuits, transistors, and other components which caused frequent shutdowns in the reactor operation. Therefore the institute decided to project and to build a new control console [7].

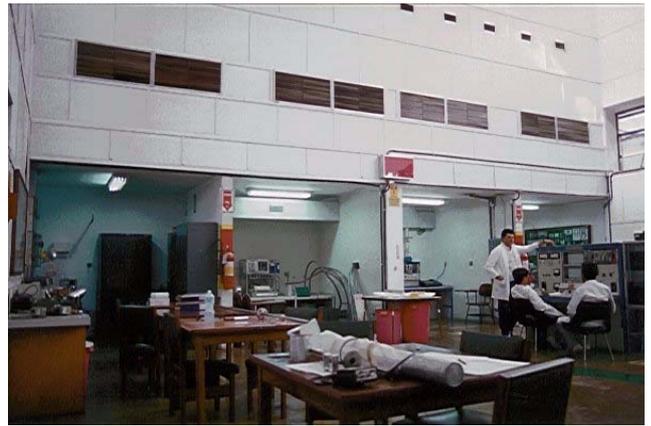
Figure 5. The Original Reactor Control Room

The civil, electrical and hydraulic installations of the IPR-R1 Reactor building remained the same since its dedication in 1960. For various years the operation staff had requested a complete reform of the installations to increase safety during reactor operation [Figure 5].

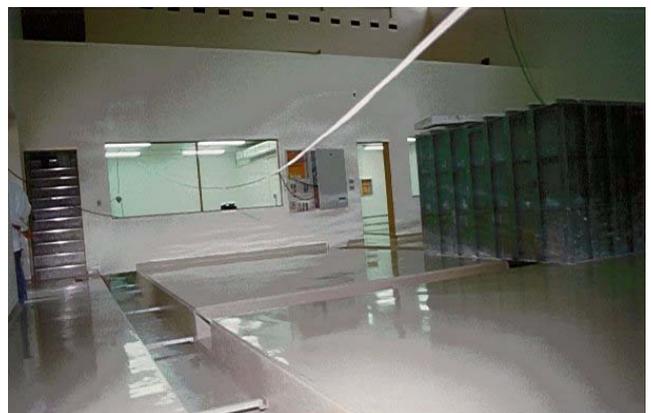
Figure 6. The New Reactor Room and the Reactor Pool Protector Casement

In June of 1994, after a meeting between technicians of CDTN and the Reactor Licensing Superintendence of CNEN, a general remodeling of several parts of the Reactor Laboratory began. The protection to the reactor installation was carefully studied and a casement of steel was built surrounding the reactor tank to protect it against any kind of damage and dust [Figure 6]

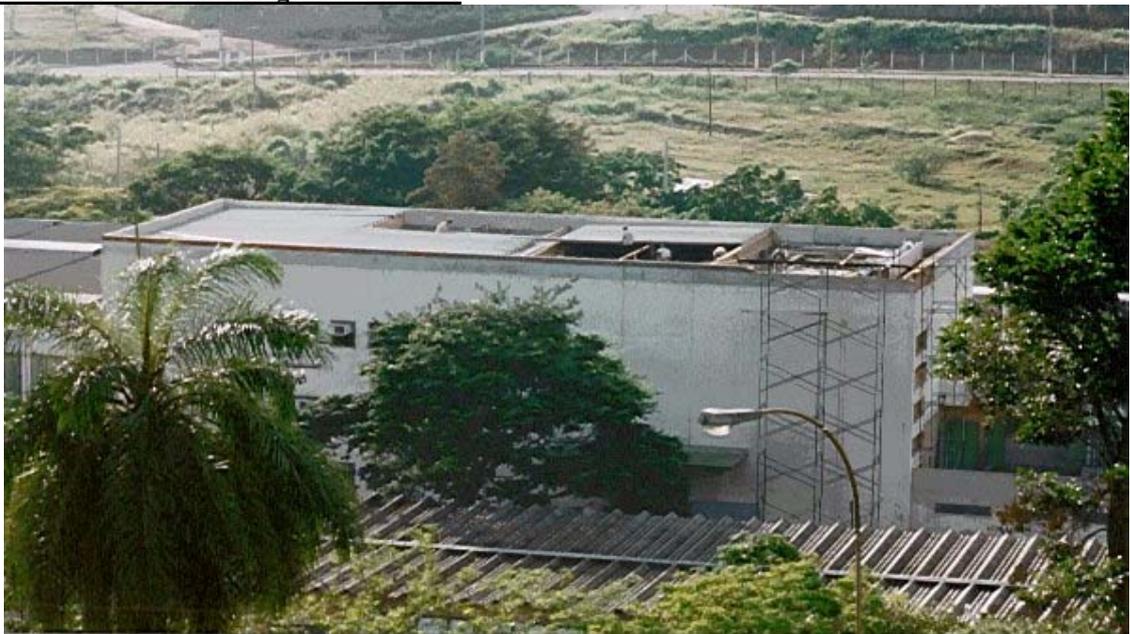
Figure 7. The New Roof of the Reactor Building

A new roof was installed on the reactor building to stop the rain water from falling directly on the concrete ceilings of the building to prevent flooding due to the deterioration of the old rain roof drains and infiltration through the roof [Figure 7].
